Project Follow-Up: Reconnecting Piper Creek

By Evan Tichonuk, Trout Unlimited Canada

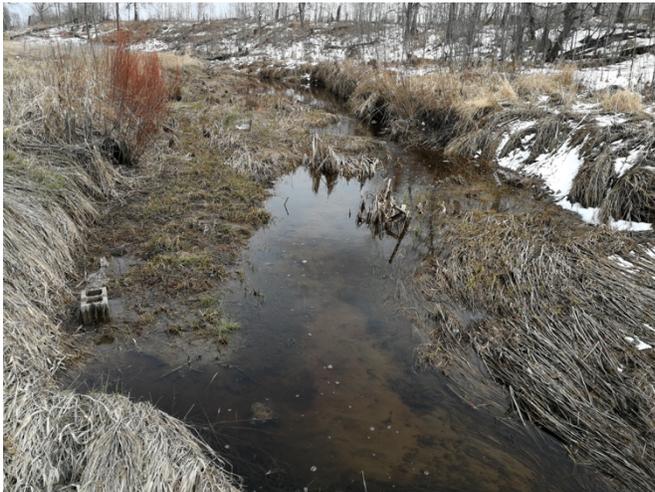
Piper Creek before restoration *Photo by Trout Unlimited Canada*

Following several decades of agricultural land use, water quality, riparian health and fish habitat had been significantly altered in Piper Creek. An improperly installed crossing of Piper Creek had resulted in several problems. Fish passage was likely impaired at most times of the year due to the culverts being perched (that is, sitting above the water they flow into), crushed, and/or blocked by debris. Following years of this obstruction, increased sediment load upstream of the crossing had led to the widening and shallowing of the stream channel.

In order to improve the overall quality of the Piper Creek watershed and significantly benefit downstream aquatic ecosystems, a project was initiated. This project was a part of Trout Unlimited Canada's (TUC) national Reconnecting Canada initiative, wherein TUC works with partners to collaboratively improve conditions at stream crossings where barriers or other environmental issues may exist. The approach taken to remediate the crossing issue in this case was to remove the structure completely as the crossing was no longer necessary.

In the fall of 2016, TUC and other partners worked with a contractor to isolate the crossing from the watercourse, remove the crossing using an excavator, and then remove the isolation, allowing the stream to flow unimpeded again for the first time in decades.

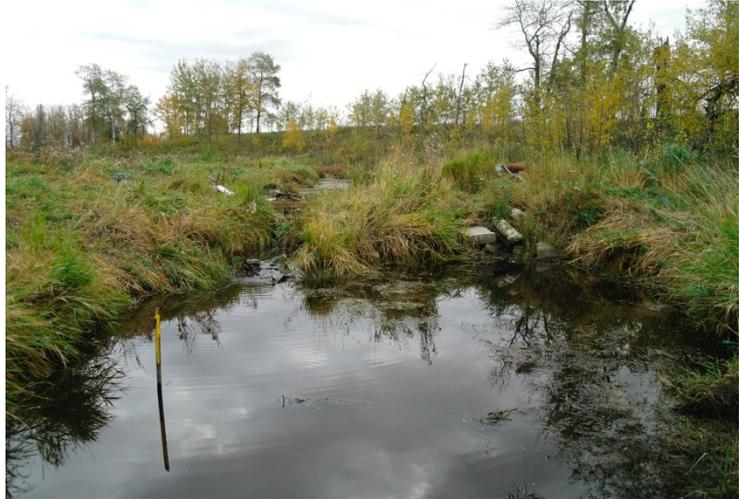
banks, and the creek has begun the process of redistributing sediment, allowing it to return to a natural narrow and meandering channel. Willows planted at the crossing are now more than six feet tall, and a number of additional riparian and wetland species have recolonized the former crossing site including cattails, sedges, and pickerel-weed. Two years after the project was completed, it is clear that recovery of the local habitat is underway.

Piper Creek after restoration *Photo by Trout Unlimited Canada*

Following the initial heavy machinery work, TUC again worked in collaboration with partners to revegetate the banks and surrounding areas with live native willow and tree stakes. The success of the project is evident as the planted shrubs and trees have begun to grow and stabilize the
